**BEFORE  
THE PUBLIC UTILITIES COMMISSION OF OHIO**

In the Matter of the Commission :  
Consideration of a Settlement Agreement : Case No. 03-2570-EL-UNC  
between the Staff of the Public Utilities :  
Commission and Columbus Southern Power :  
Company and Ohio Power Company. :

**Staff**  
**Concerns and Recommendations**  
**About**  
**Columbus Southern Power Company**  
**And**  
**Ohio Power Company's**  
**Provision of Electric Service**

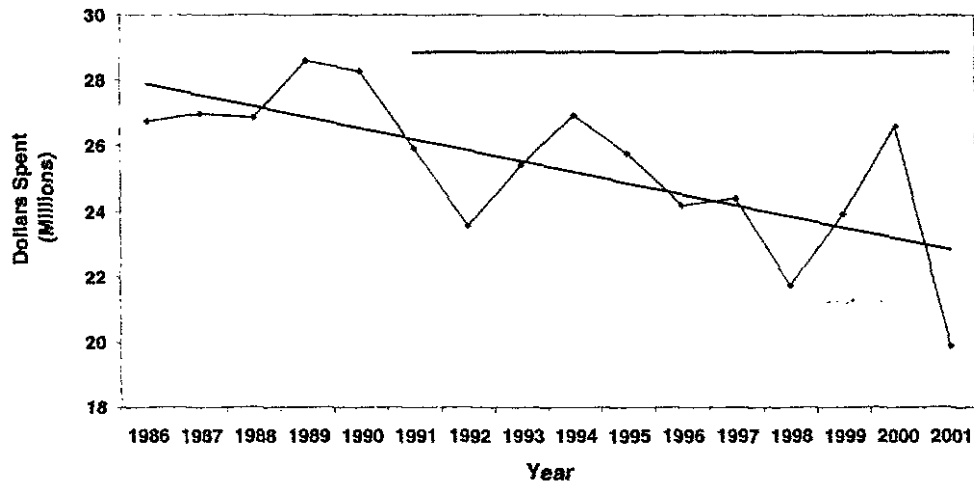
### CSP Distribution Maintenance Expenditures

The horizontal line located on the two charts above represents the Companies' annual jurisdictional distribution maintenance expense that the Commission authorized the Companies to recover through base rates in their most recent base ratemaking proceedings (these expenses are stated in 2001 dollars consistent with all other expense data included on the chart).

ESSS Rule 26 (B) also requires EDUs to report their distribution maintenance expenses for the reporting period. Because this data is also required to be filed with the Companies' FERC Form 1 Annual Reports, the Staff was able to review the Companies' distribution maintenance expense data for the last sixteen years. Staff found that both Companies significantly reduced their expenditures for distribution maintenance during 2001. The following charts illustrate the Companies' declining trends in distribution maintenance expenditures for 1986 through 2001.<sup>3</sup>

In CSP's last base rate case (Case No. 91-418-EL-AIR), the Commission granted the Company's request for an additional allowance of \$2,249,605 above the Company's 1991 jurisdictional distribution maintenance expense. The Commission authorized the Company to recover \$28,849,990 for annual jurisdictional distribution maintenance expense through its approved base rates. The chart titled "CSP Distribution Maintenance Expenditures" shows that CSP under-spent a total of \$46,157,887 for the period 1992 through 2001 (CSP's current base rates became effective in 1992).
